National Transportation Safety Board
Operations and Human Performance Groups Factual Report

Accident No.: DCA04MM015

Description: Capsize of Seaport Taxi *Lady D*.

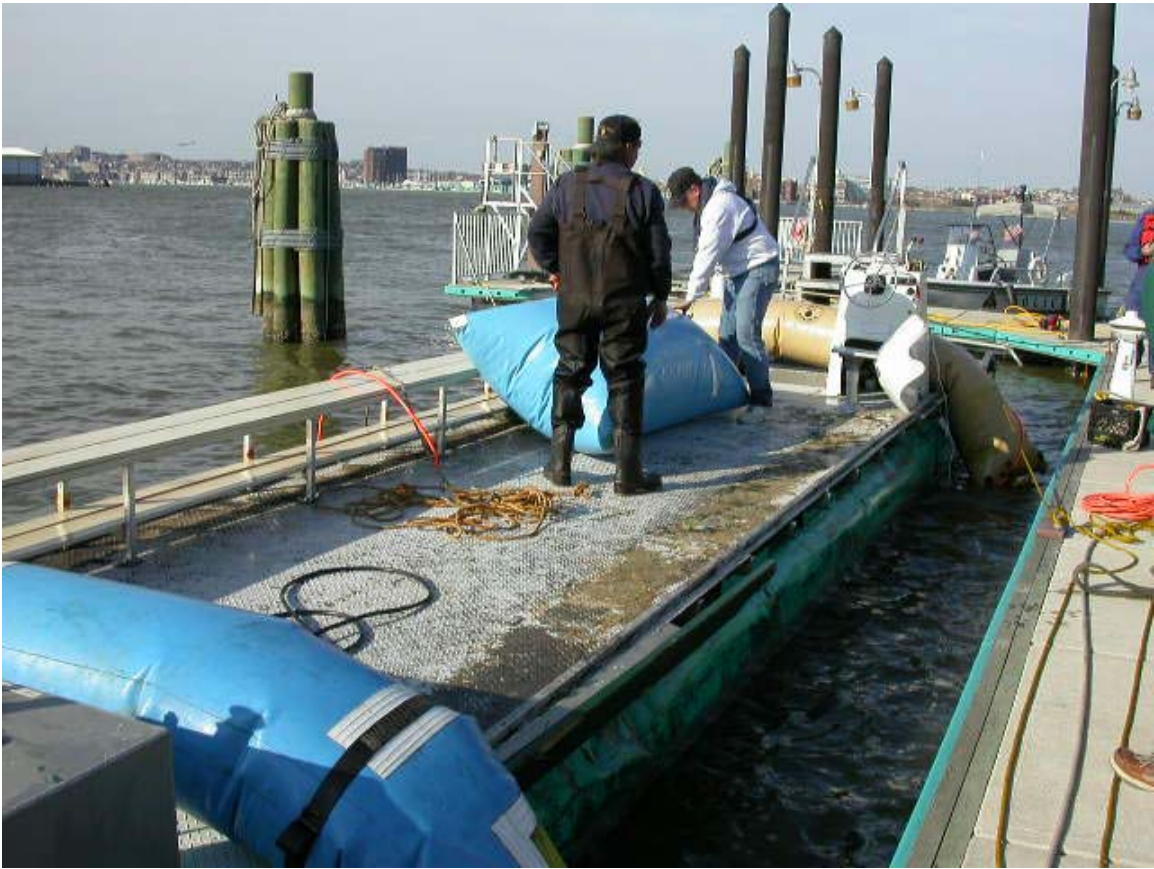
Lady D after the accident-NTSB photo

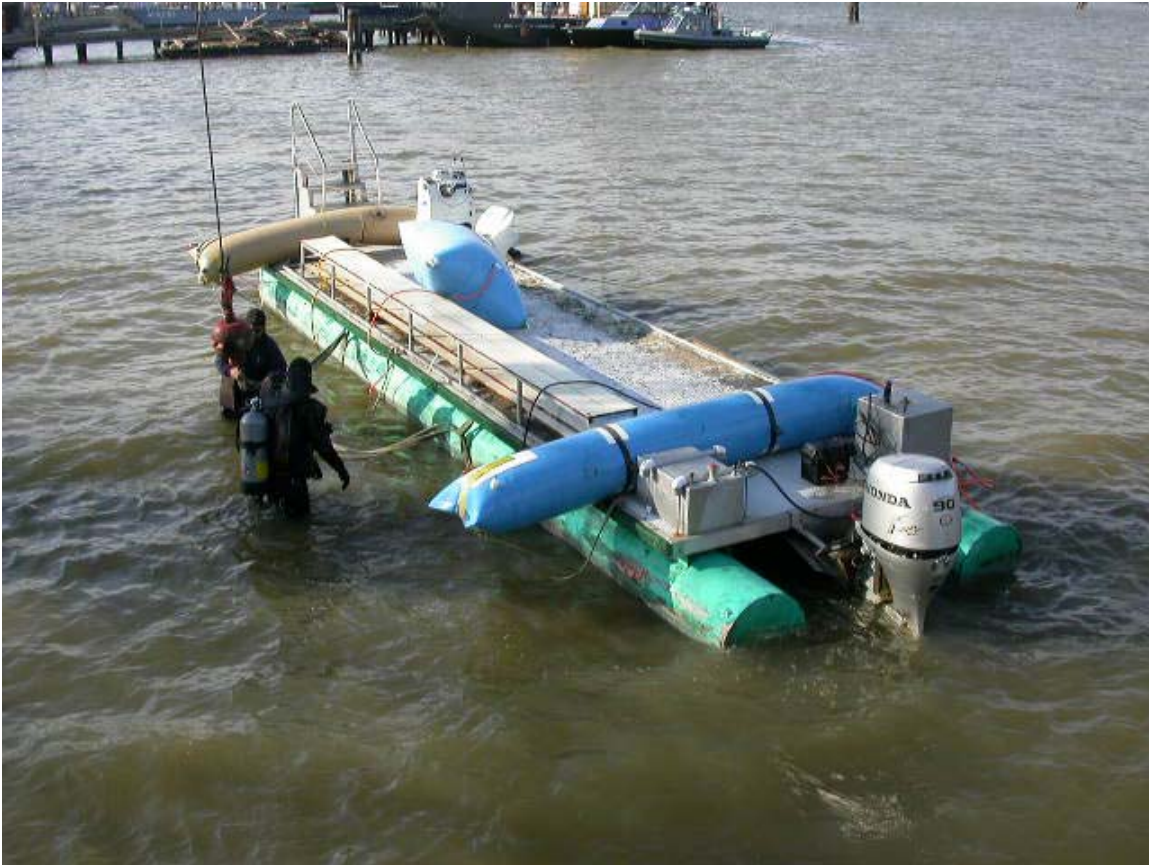
3 The Lady D after the accident, upright, showing the forward loading ladder-NTSB photo

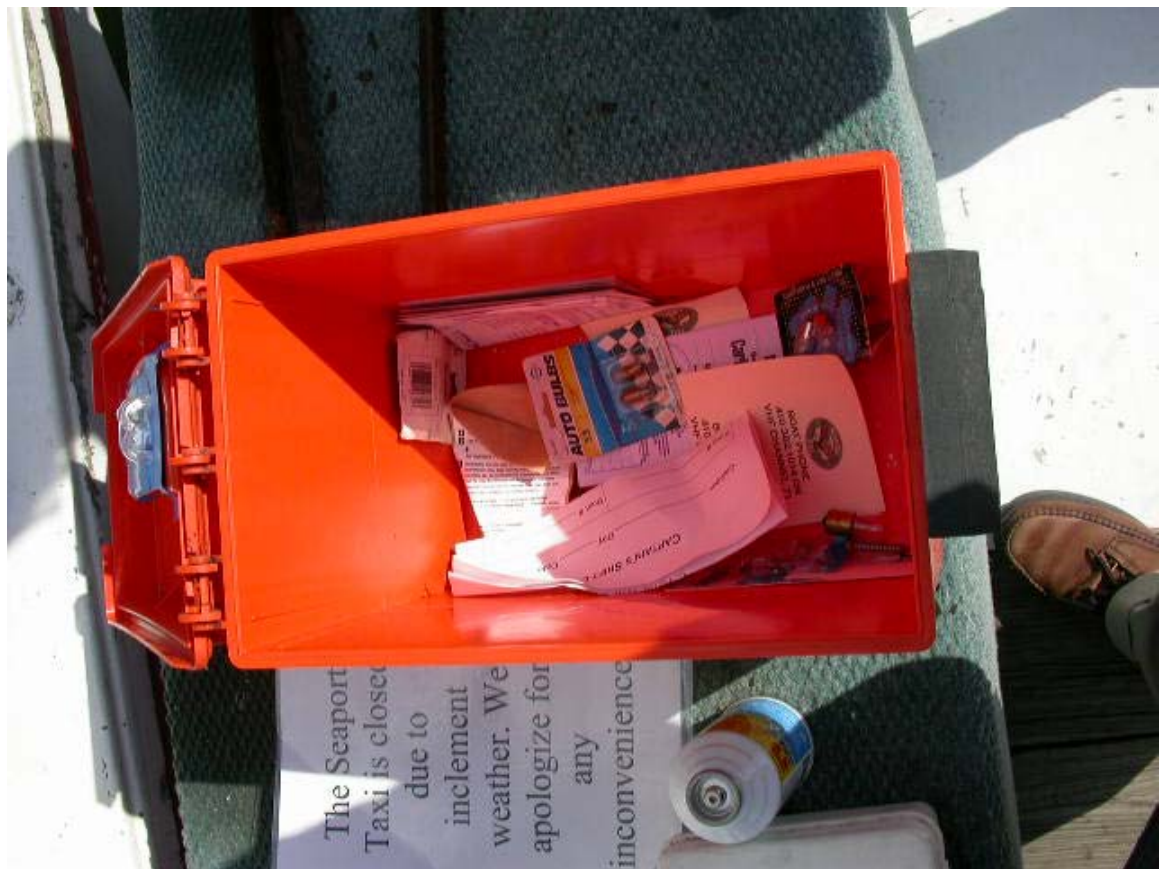
9 A typical box of equipment on Seaport Taxi boats-NTSB photo

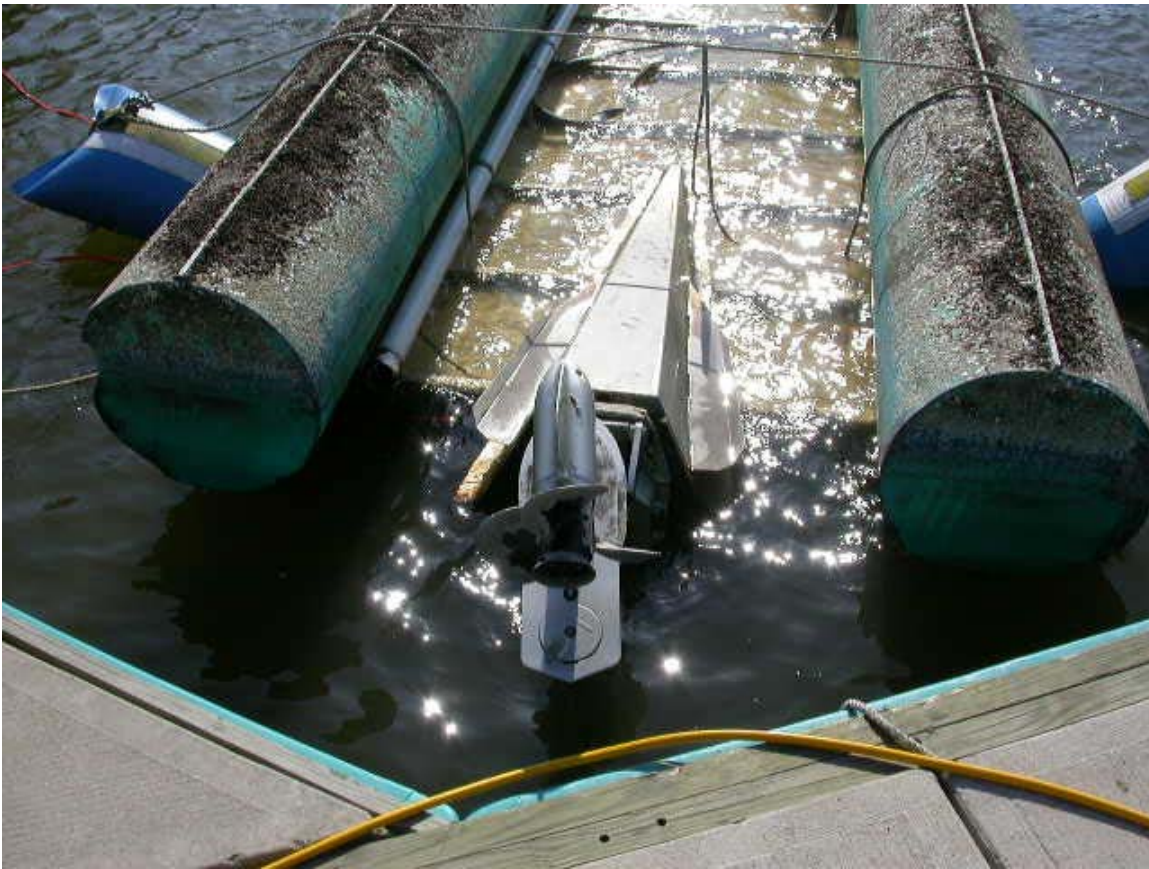
5 After the accident, the canopy and the starboard passenger bench were missing.
6 The boat had two fuel tanks mounted outside of the cabin, just forward of the motor
7 mount. The boat maintained flotation, but was declared a total loss.

8
9 Lady D, after the accident-NTSB photo
